Release Note for AlliedWare Plus Software Version 5.5.3-1.x

AlliedWare Plus OPERATING SYSTEM

AMF Cloud
SBx81CFC960
SBx908 GEN2
x950 Series
x930 Series
x550 Series
x530 Series
x530L Series

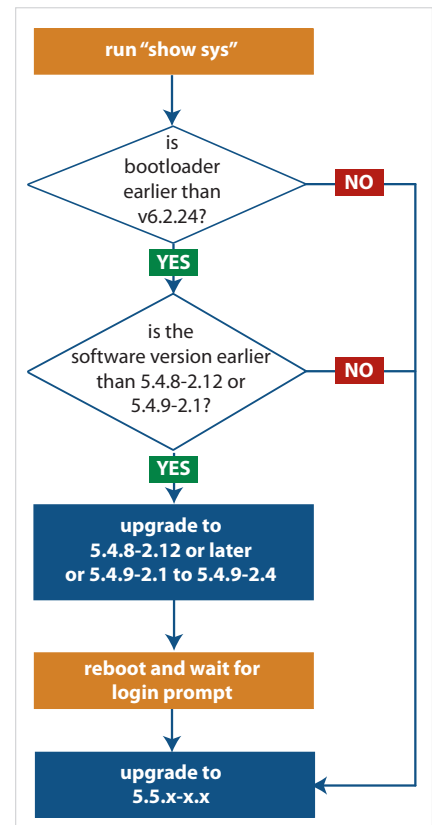
To see your bootloader and current software version, check the “Bootloader version” and “Software version” fields in the command:

```
awplus# show system
```
